CAPSULE
SCARBORO HOUSE

INVENTORY FORM FOR STATE HISTORIC SITES SURVEY

Scarboro House

509 Chesapeake Ave.

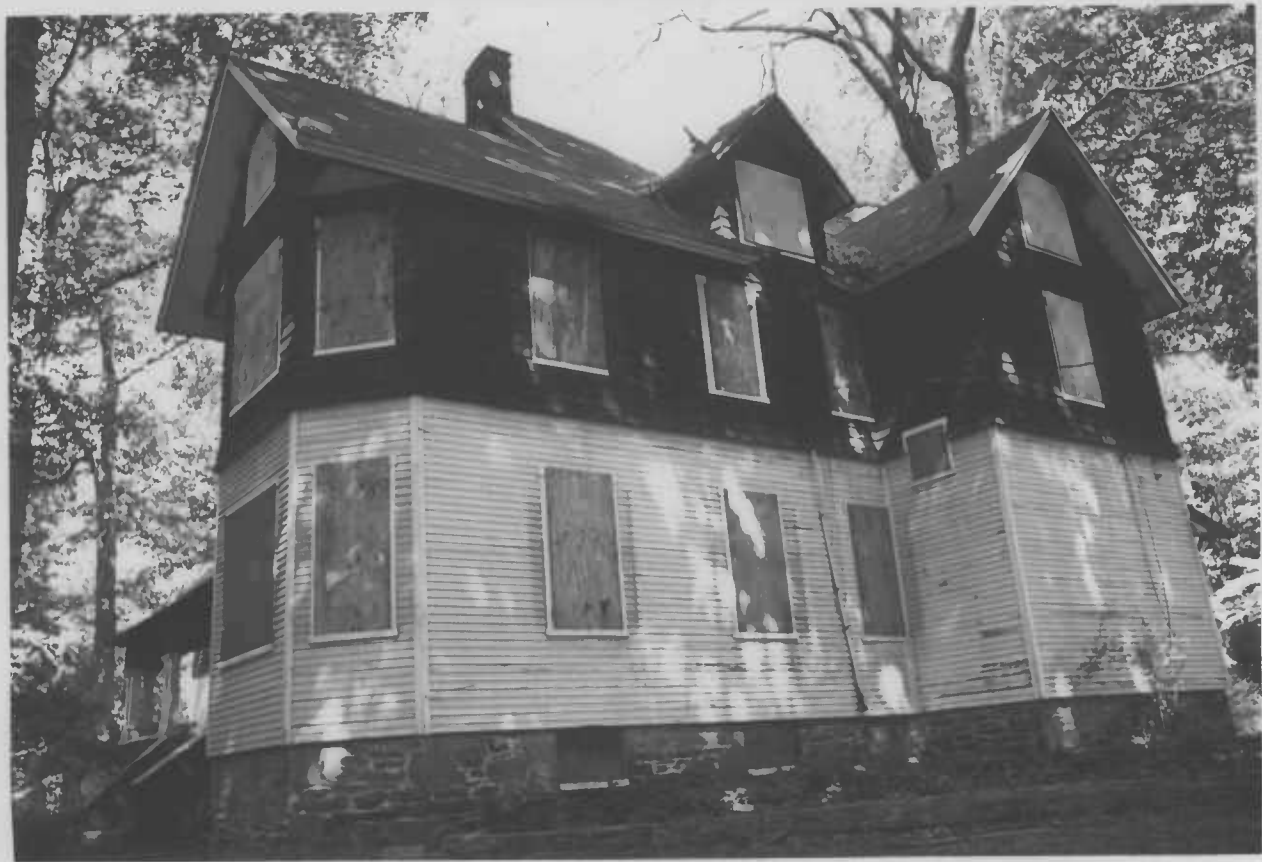
W. FACADE

Three bays of the northern projection have a western exposure. The main block has centrally placed pedimented dormers that suggest a cross-gable.

The symmetry is broken by the fact that the southern one-third of the facade projects 6 feet to the West, is gabled, and windowless on the first level. It is also vented by a single window on the second and attic level.

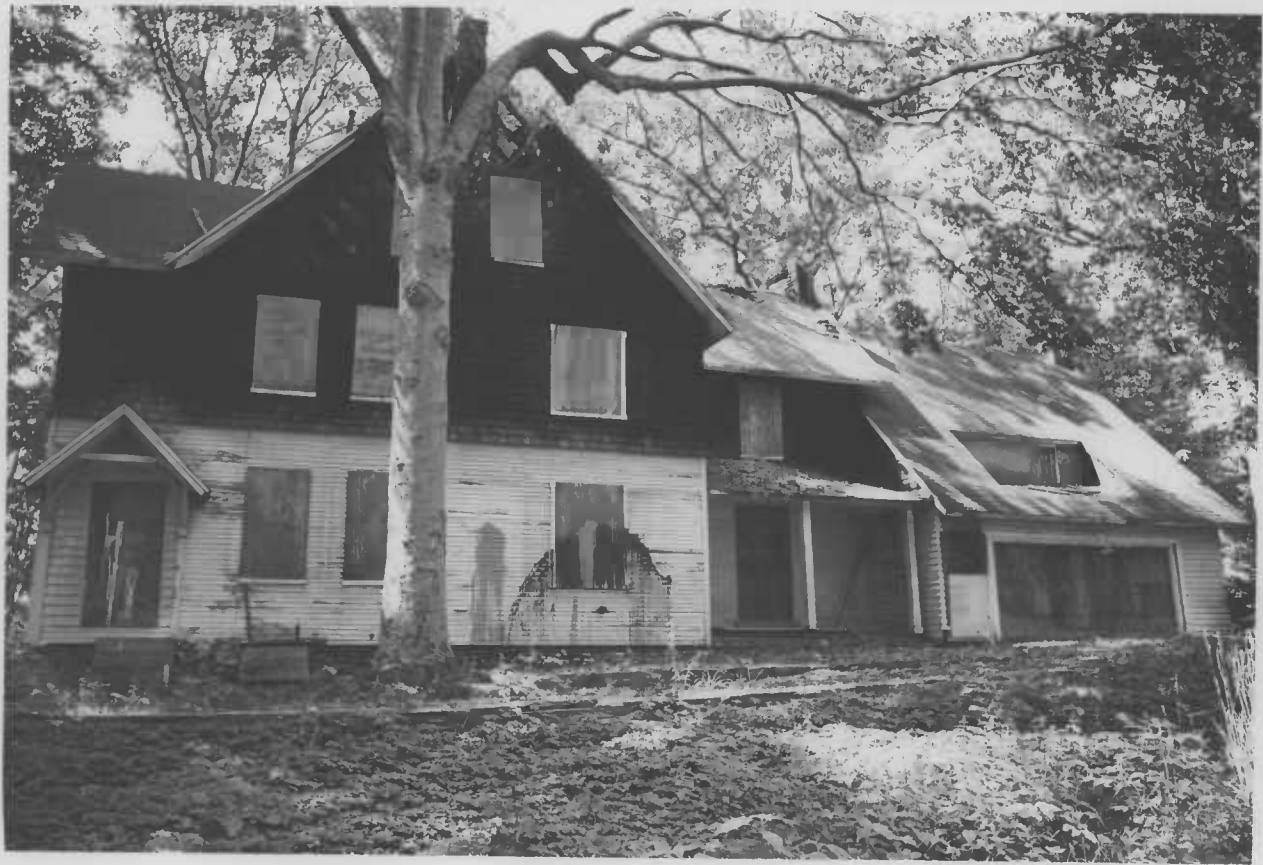
SCARBORO HOUSE
S. FACADE

The south facade is the most regular although there are four unevenly spaced bays. The first level of the westernmost bay was once apparently occupied by a recessed entrance which still has a bracketed hood that constitutes a pediment over a keyed arch. This arch is 5 inches wide, has an opening of 66 inches and measures 99 inches from the top of the key to the bottom of the opening.

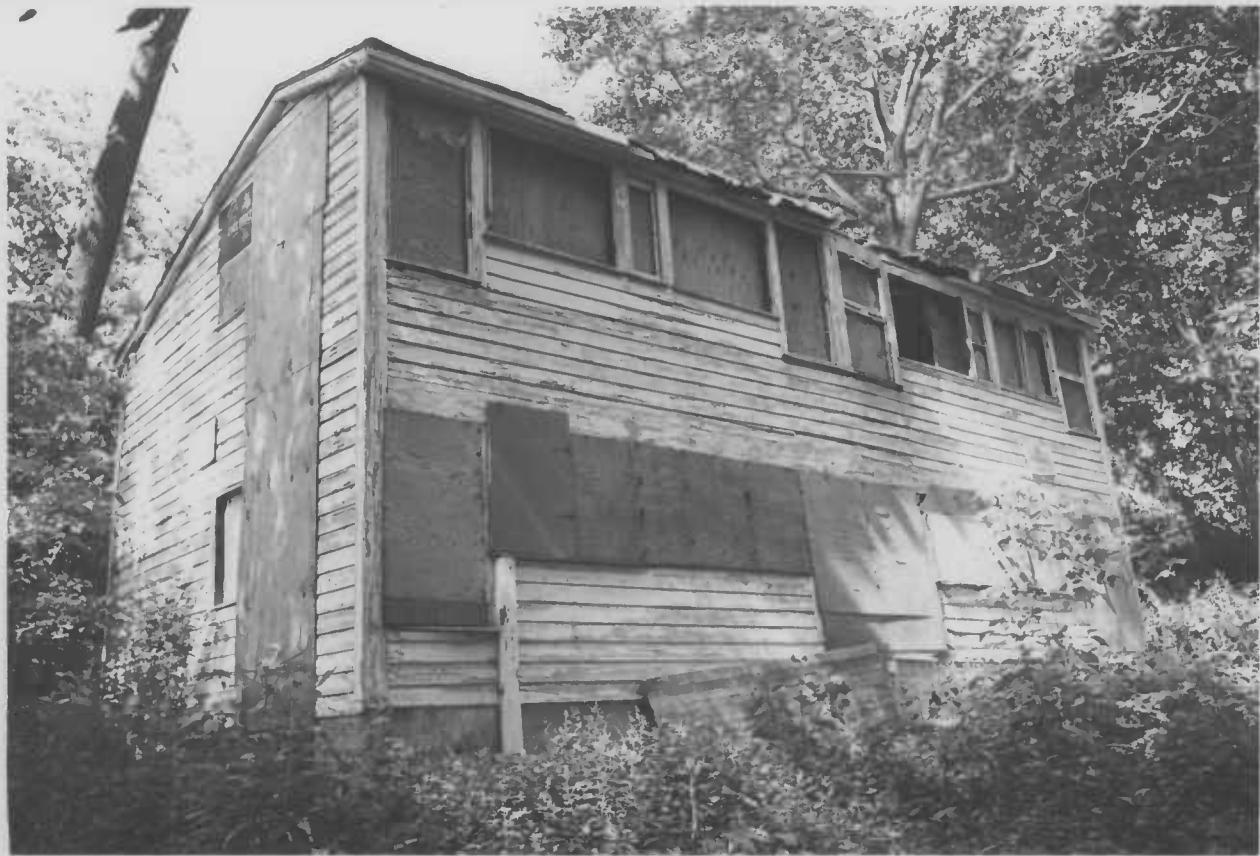
OUTBUILDING -

The second building is a two story frame structure on a concrete foundation which seems to have been designed to house fowl. The building measures 16 feet 3 inches wide by 32 feet long. The siding is german clapboards.

The irregular feature is that the shed roof is higher on the west end than the east. The ridge sets back 3 feet from the south wall and gives a cat slide roof appearance. Between the eaves and the ground the southeast corner measures 11 feet while the southwest corner measures $13\frac{1}{2}$ feet.
